# Updated Dates of Asbestos Removal

## Asbestos Register

Report Number	OH98049F2
Report Issue Date	19-Jul-18
Report To	Renee Inkster University of Southern Queensland West St Toowoomba QLD 4350
Client Reference	Purchase Order No. 0008096988
Job Description	Ipswich Campus Asbestos Audit 2018
Dates Conducted	14 - 18 June 2018
Responsibility for Sampling	Simtars (R. Greenfield) - Reviewed by Danielle Codd
Approved Signatory	Anne Kelly A / Senior Occupational Hygienist COH / MAIOH

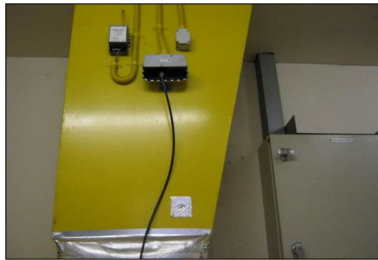
8728: B Block, A/C Heater Bank

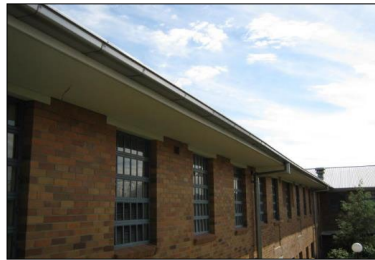
8730 B: B Block, Eave Soffits

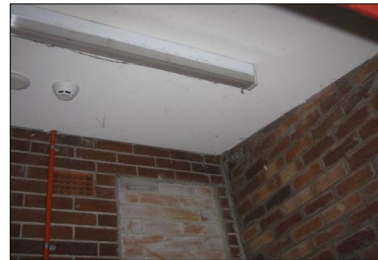
8735: C Block, C115, ceiling

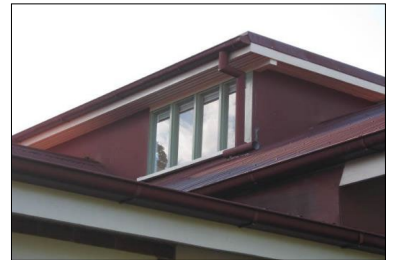
8737 B: External Skylight walls

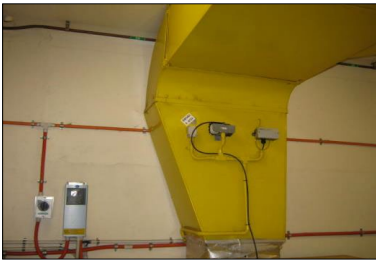
8724: B Block, A/C Heater Bank

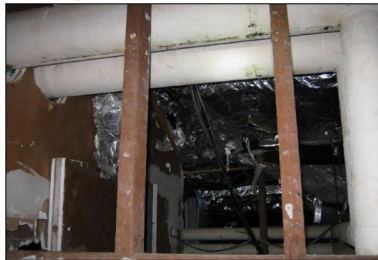
8729 A: B Block, Debris in ceiling space, on timber studs

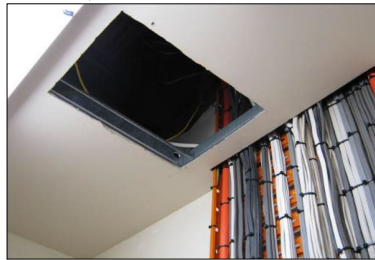
8731: B Block, Plant Room, ceiling

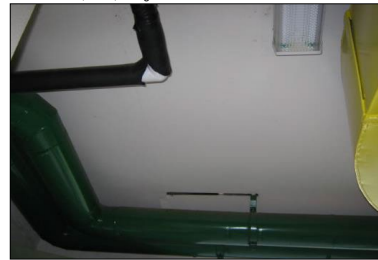
8736: C Block, Plant Room, ceiling

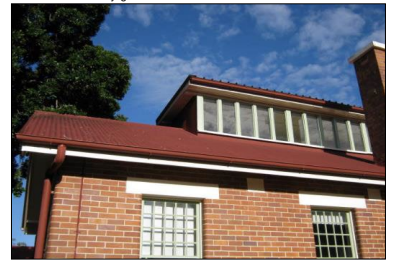
8737 C: External Skylight walls

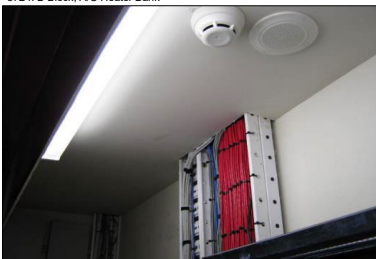
8725: B Block, Comms, Rm B239A, ceiling

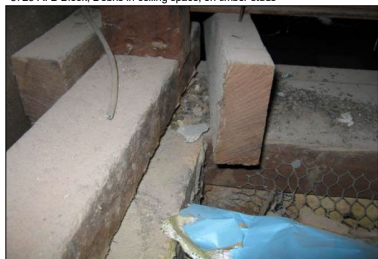
8729 B: B Block, Debris in ceiling space

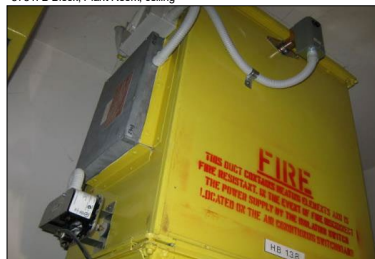
8732: B Block, A/C Heater Bank

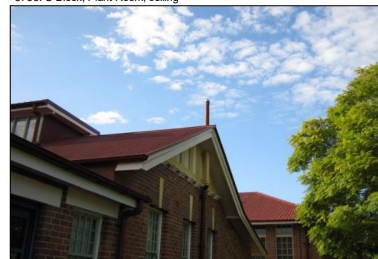
C Block, Vent Pipe / C Block Gable

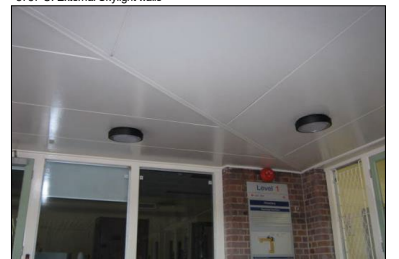
8738: C Block, veranda ceilings

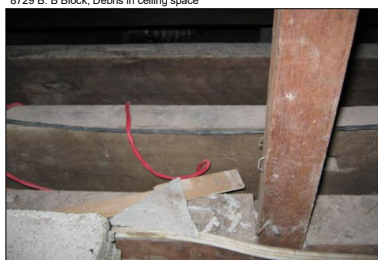
8729 C: B Block, Debris in ceiling space

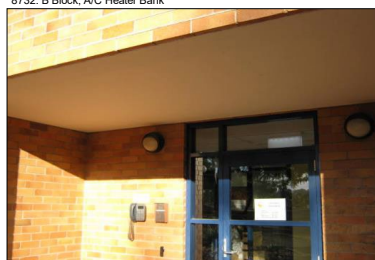
8734: B Block, B112 entry ceiling

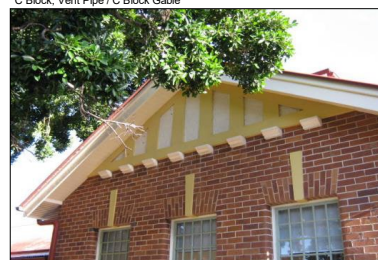
C Block, Gable

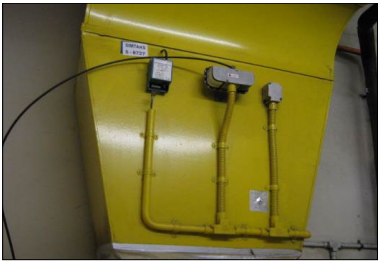
8727: B Block, A/C Heater Bank

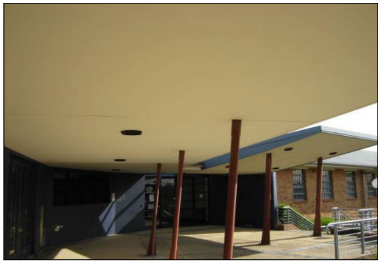
8730 A: B Block, Eave Soffits

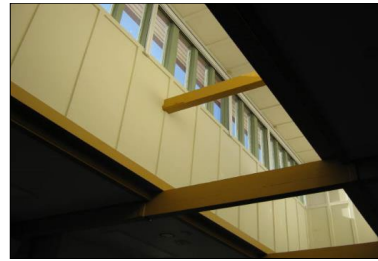
8737A: Internal Skylight walls

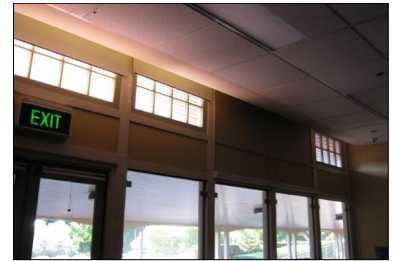
8739 B: C Block, upper wall panels

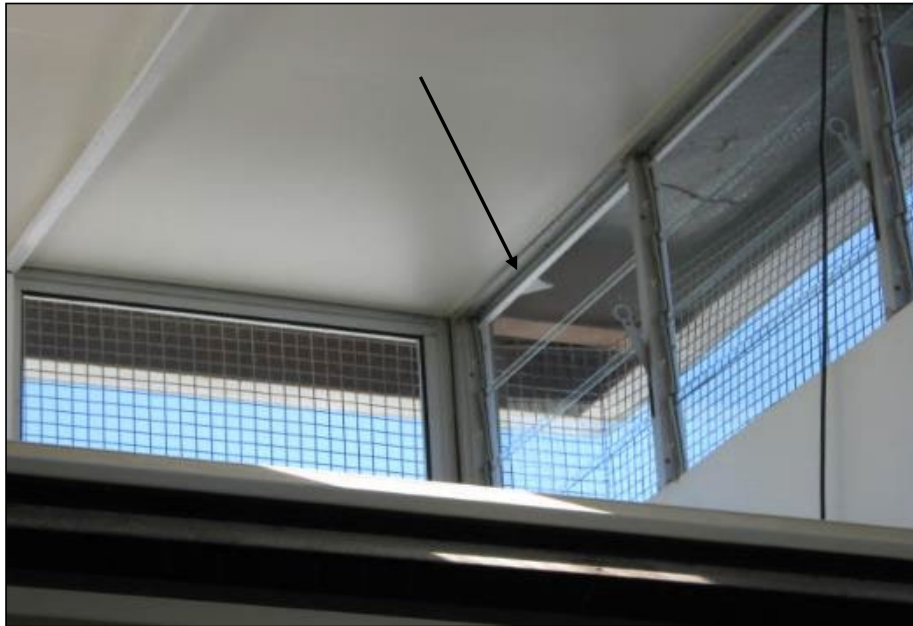
V1 Block: Skylight Debris

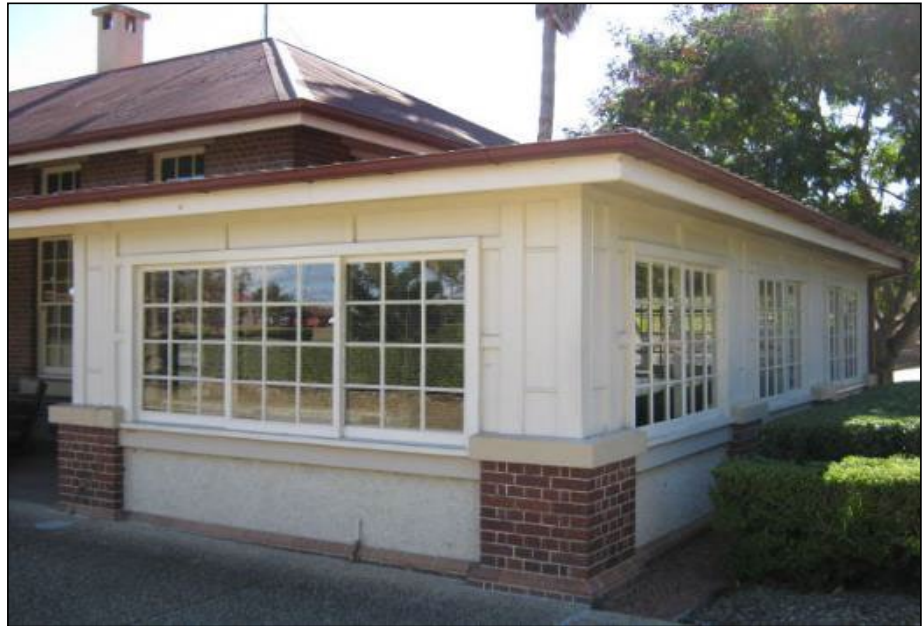
8771A: T Block, wall cladding, East end

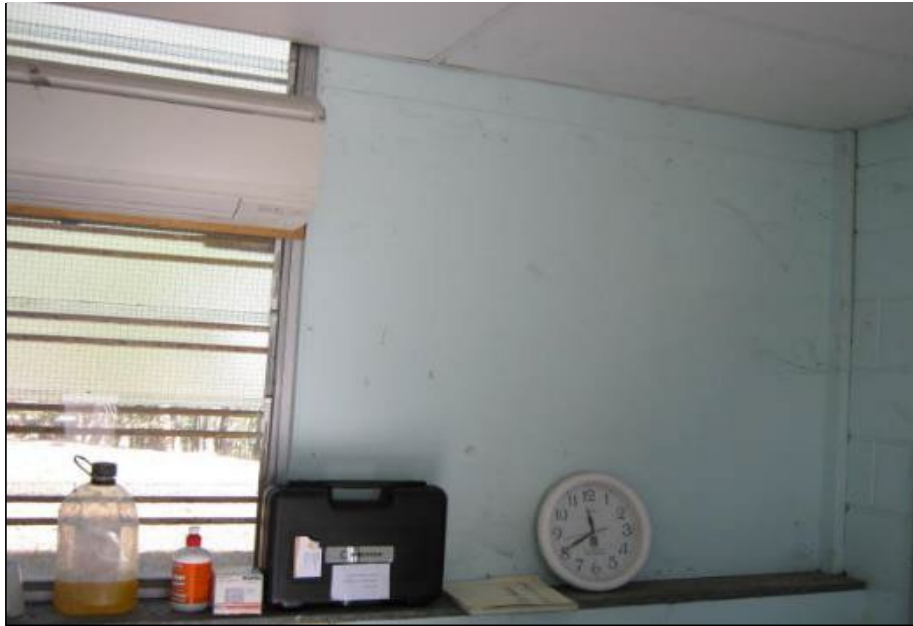
8770: V2 Block, wall cladding, V2113

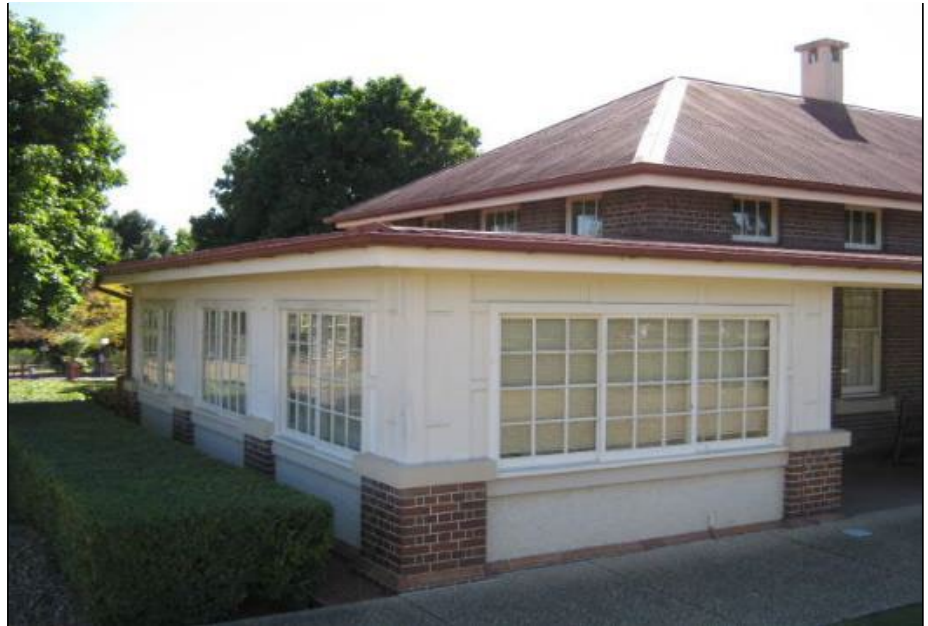
8771B: T Block, wall cladding, West end

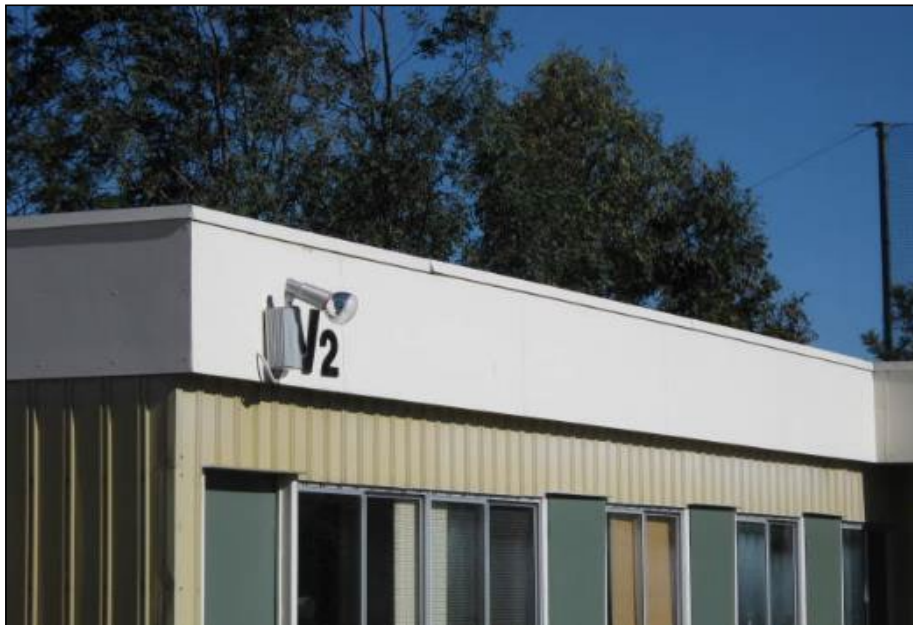
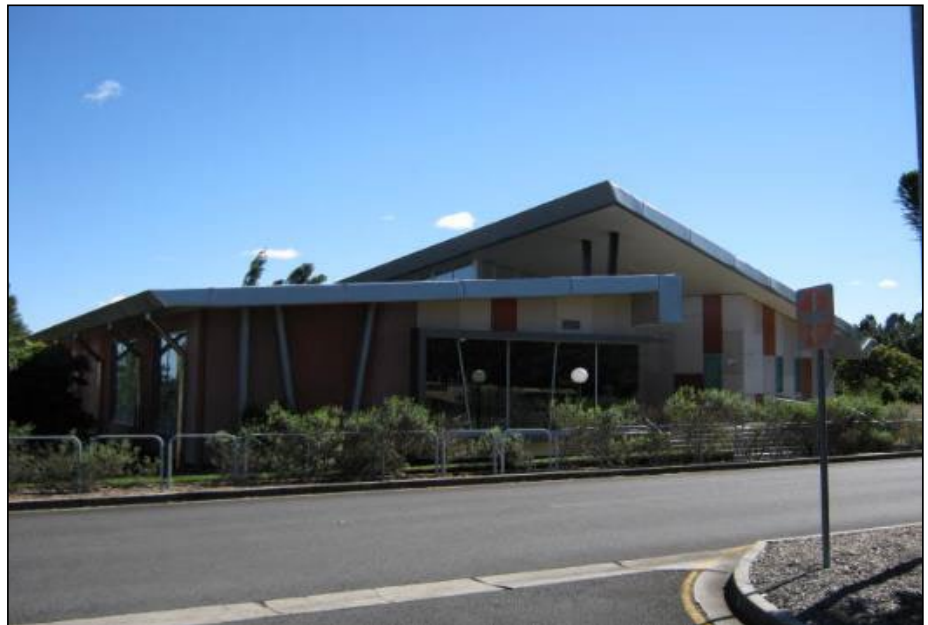
8764 B / 8765 B: V2 Block, fascia & eave soffits

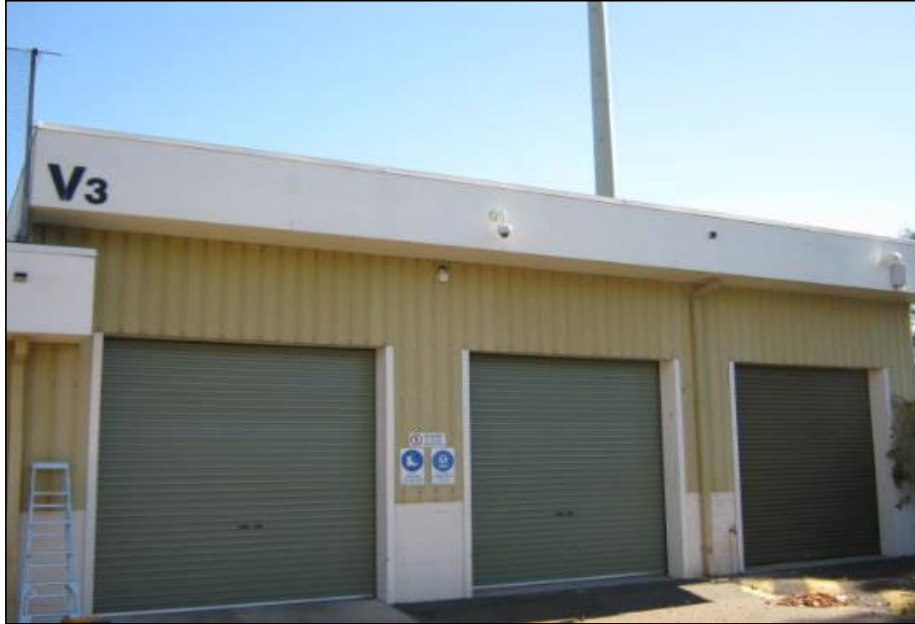
8764 C: V3 Block, fascia

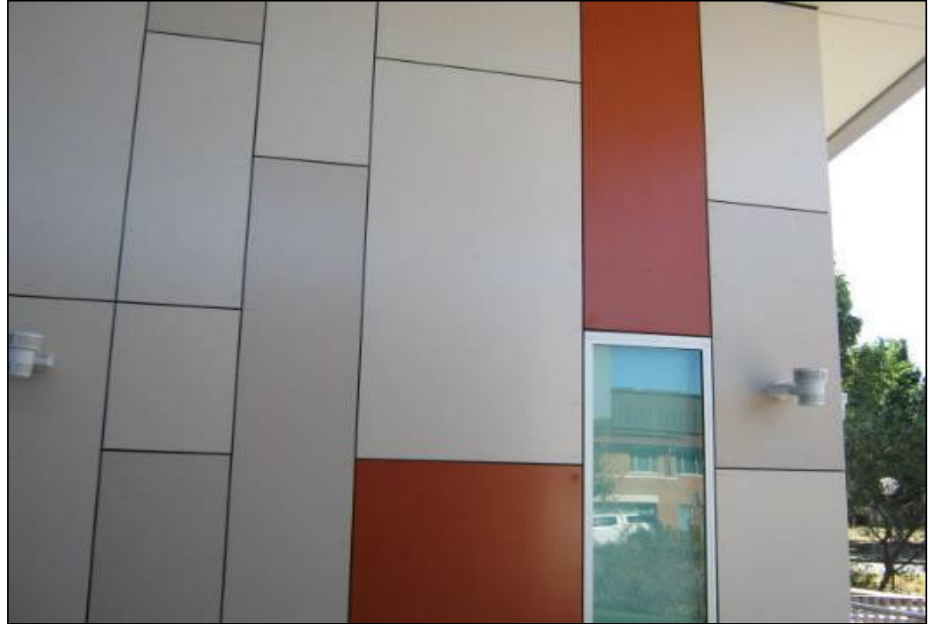
8722 A: F Block, wall panels

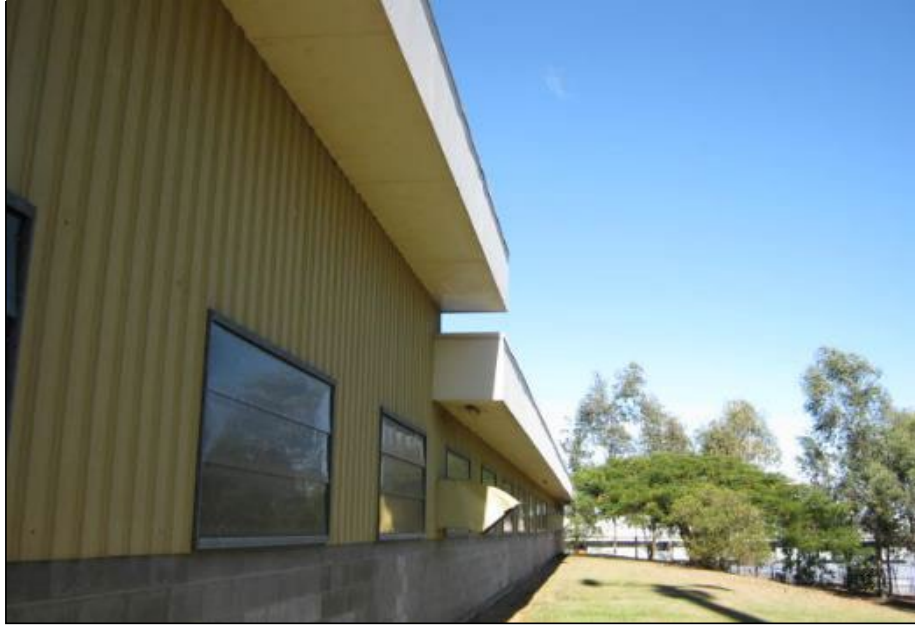
8765 C: V3 Block, eave soffits

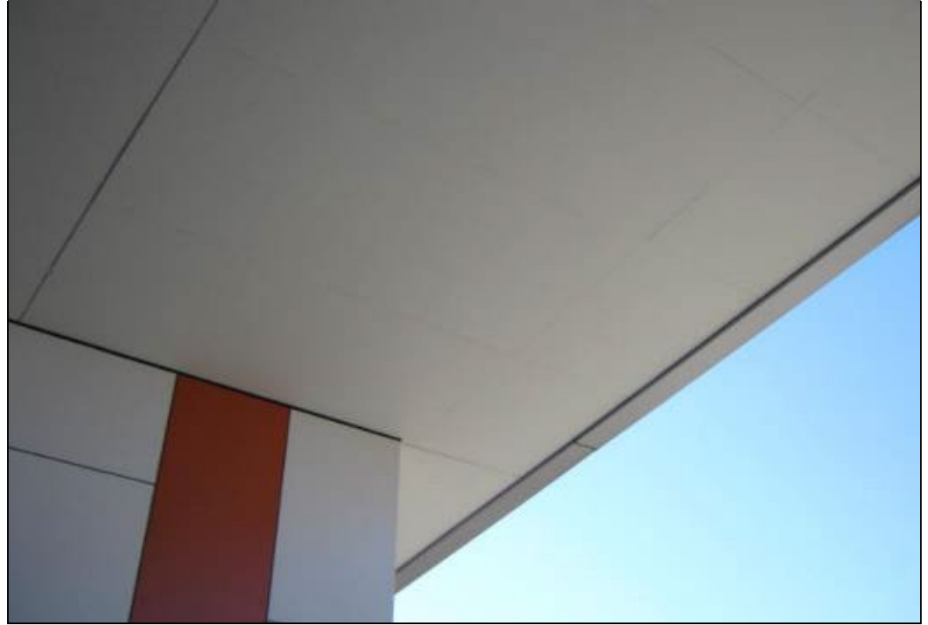
8722 B: F Block, eave soffits
